# **Field Demonstration of Condition Assessment Technologies for Wastewater Collection Systems**

**Kathy Martel, P.E.  
The Cadmus Group, Inc.**

**National Risk Management Research Laboratory  
Office of Research and Development  
U.S. Environmental Protection Agency  
Cincinnati, Ohio 45268**

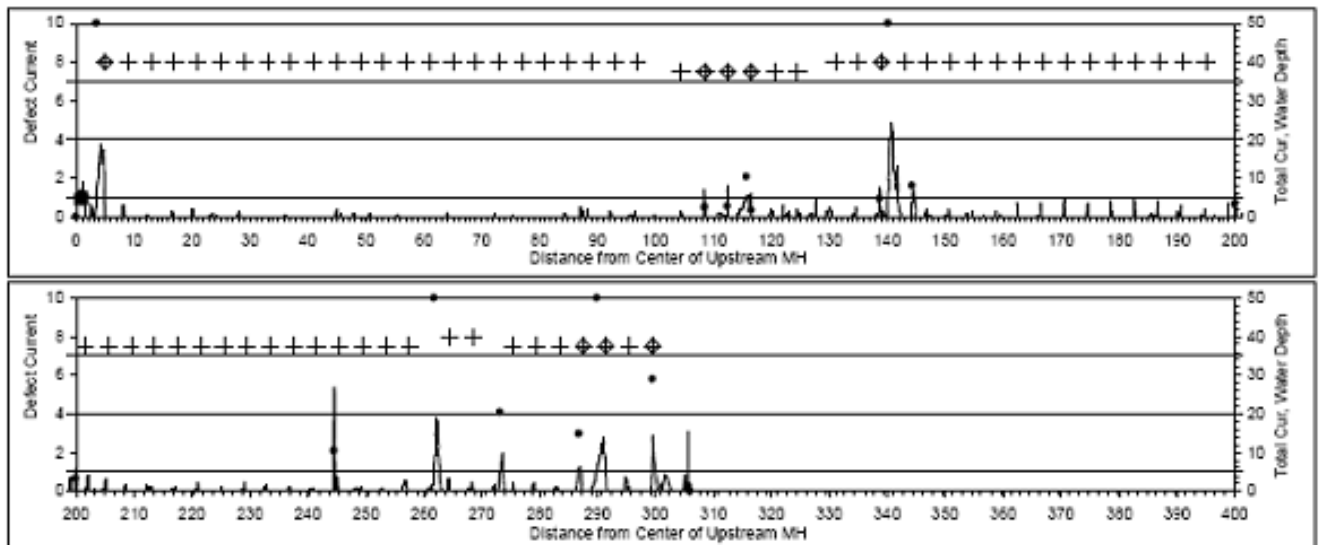
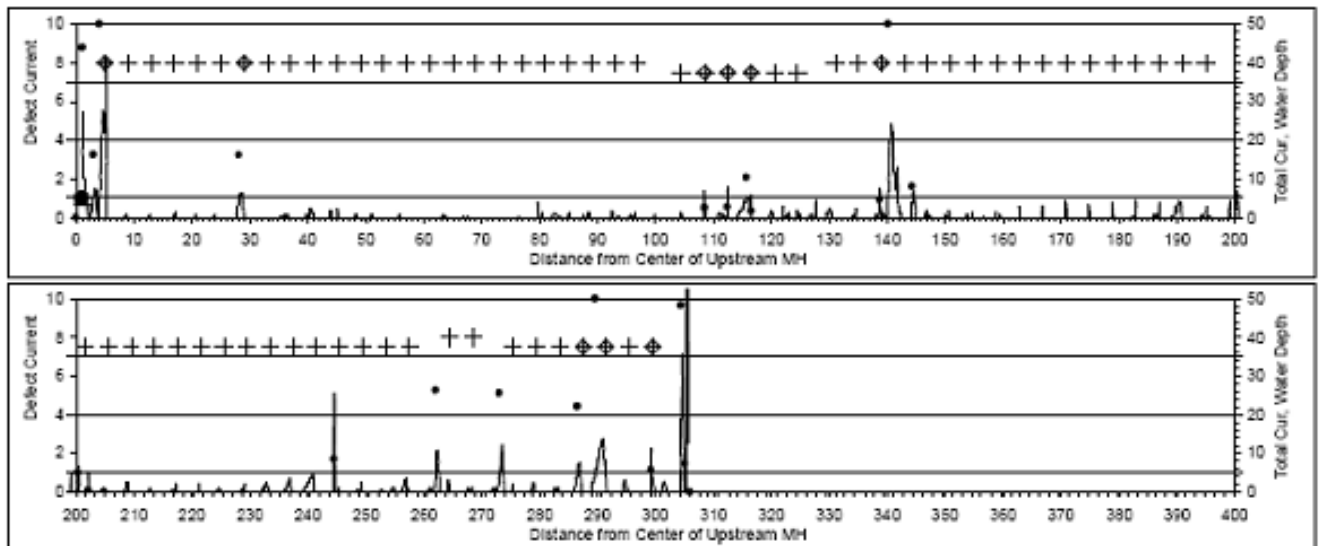
The precision of the electro-scanning results was evaluated by duplicate inspections of the pipe segment from SMH 101 to SMH 100 which was 306-ft long (See comparisons in Table 5-14 and Figure 5-7). The two scans were very similar; scan B revealed only three more defects than scan A. The two scans had several differences including a small defect at 29-ft, which is only seen in the second scan, and a defect at 6-ft, which had a higher electrode current in the second scan (i.e., a higher severity). The observed differences in results may be attributed to changes in the sonde's travel rate which occurred at the start and end of the scan. The high current at the end of the second scan may have been caused by a steel pole used to move the probe into the middle of the downstream manhole. Although the ground stake placement varied between the two scans, it was not expected to affect the results.

**Figure 5-7. Duplicate Electro-Scans for Pipe Segment 101 to 100.**

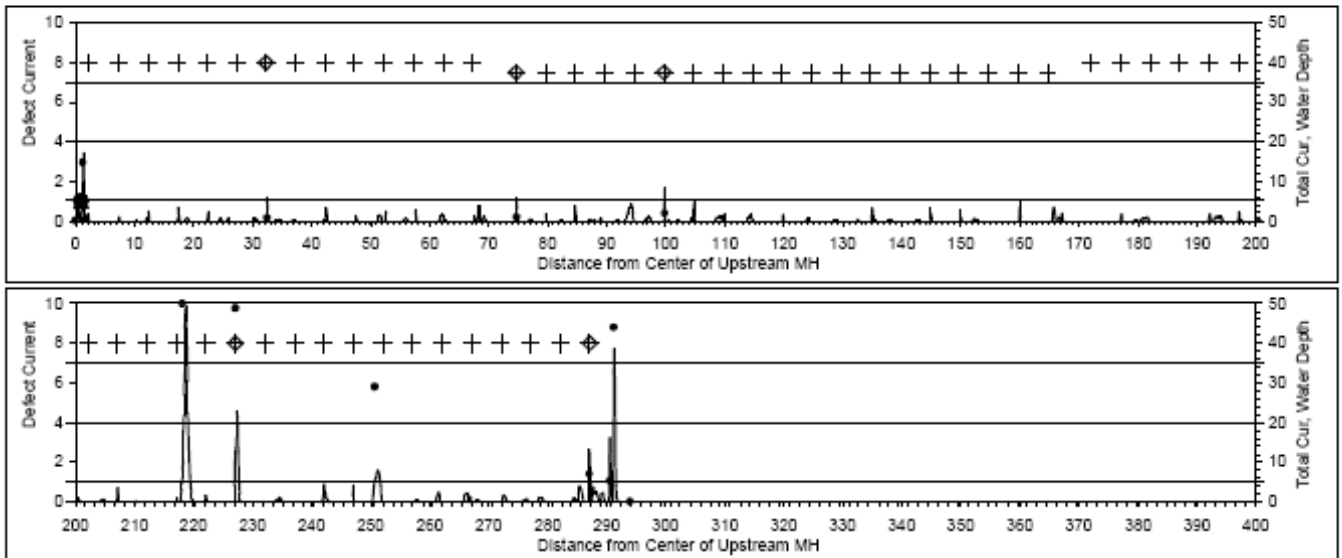
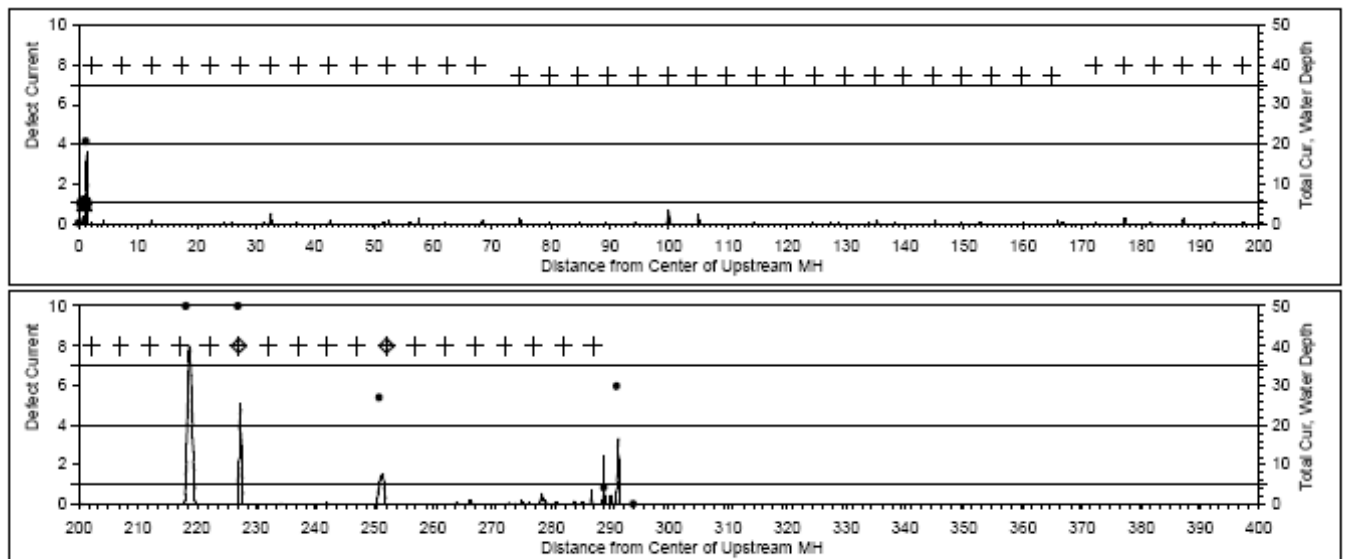
Comparison of results for the FELL-41 and MSI-1620 electro-scanning systems obtained for three pipe segments (SMH 102 to SMH 101; SMH 127 to SMH 125; and SMH 174 to SMH 173) shows that the FELL-41 generally registered more increases in electrode current than the MSI-1620 (Tables 5-15, 5-16, and 5-17; Figures 5-8, 5-9 and 5-10). Figures 5-8, 5-9, and 5-10 show more small current spikes, some of which exceeded the threshold and are listed as small defects. Anomalies that are seen on the traces for both instruments tend to be greater on the FELL-41 results. For example, in pipe segment 102-101, small joint defects at 74-ft, 100-ft, and 287-ft detected by the FELL-41 system were not detected above the threshold by the MSI-1620. However, current spikes at the pipe entry for SMH 101 were significantly greater for the FELL-41. For the segment from SMH 127 to SMH 125, FELL-41 detected small joint defects at 6-ft, 175-ft, and 185-ft. These were not detected above the threshold by the MSI-1620. These results suggest that the FELL-41 unit may be more sensitive than the MSI-1620.

**Figure 5-8. Comparison of FELL-41 (upper) and MSI-1620 (lower) for Pipe Segment 102-101.**

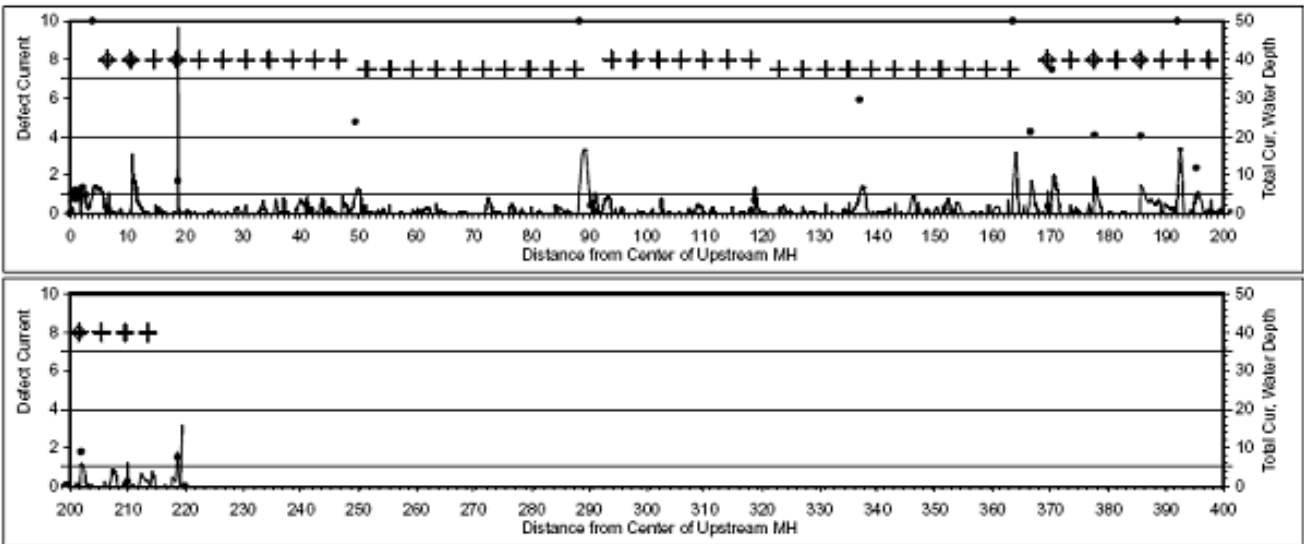
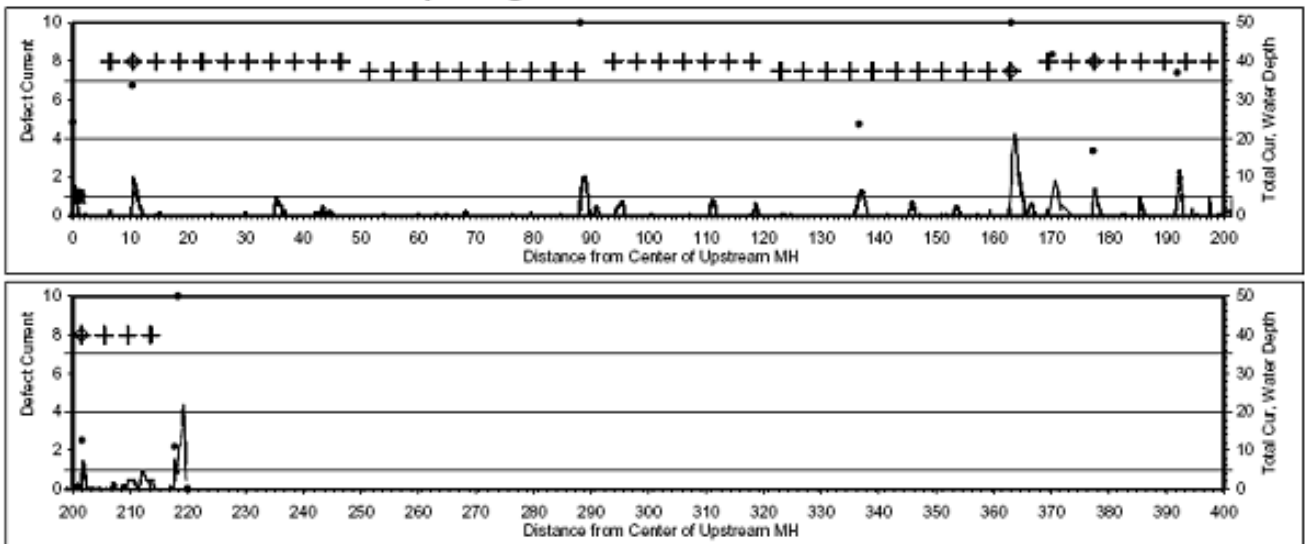
**Figure 5-9. Comparison of FELL-41 (upper) and MSI-1620 (lower) for Pipe Segment 127-125.**

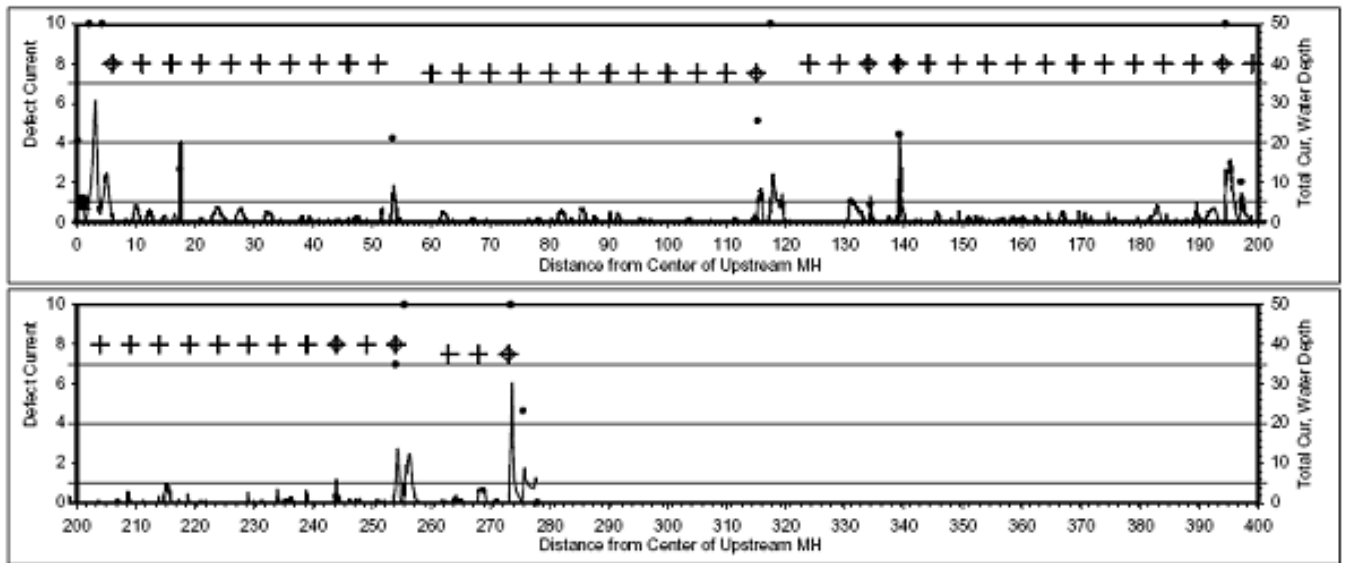
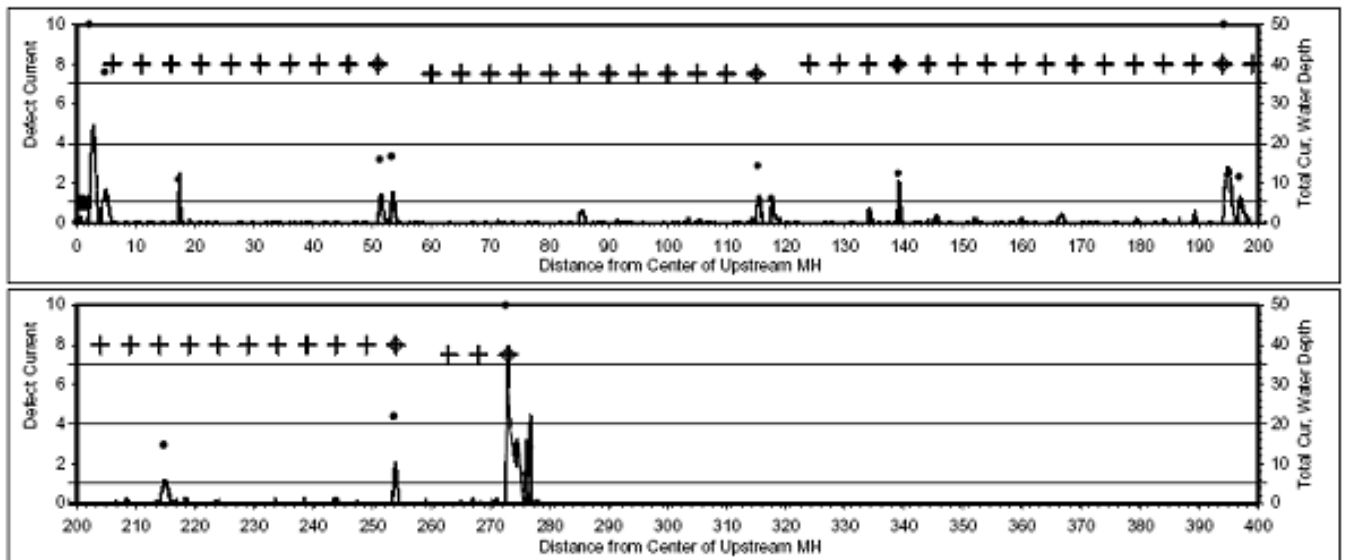
**Figure 5-10. Comparison of FELL-41 (upper) and MSI-1620 (lower) for Pipe Segment 174-173.**

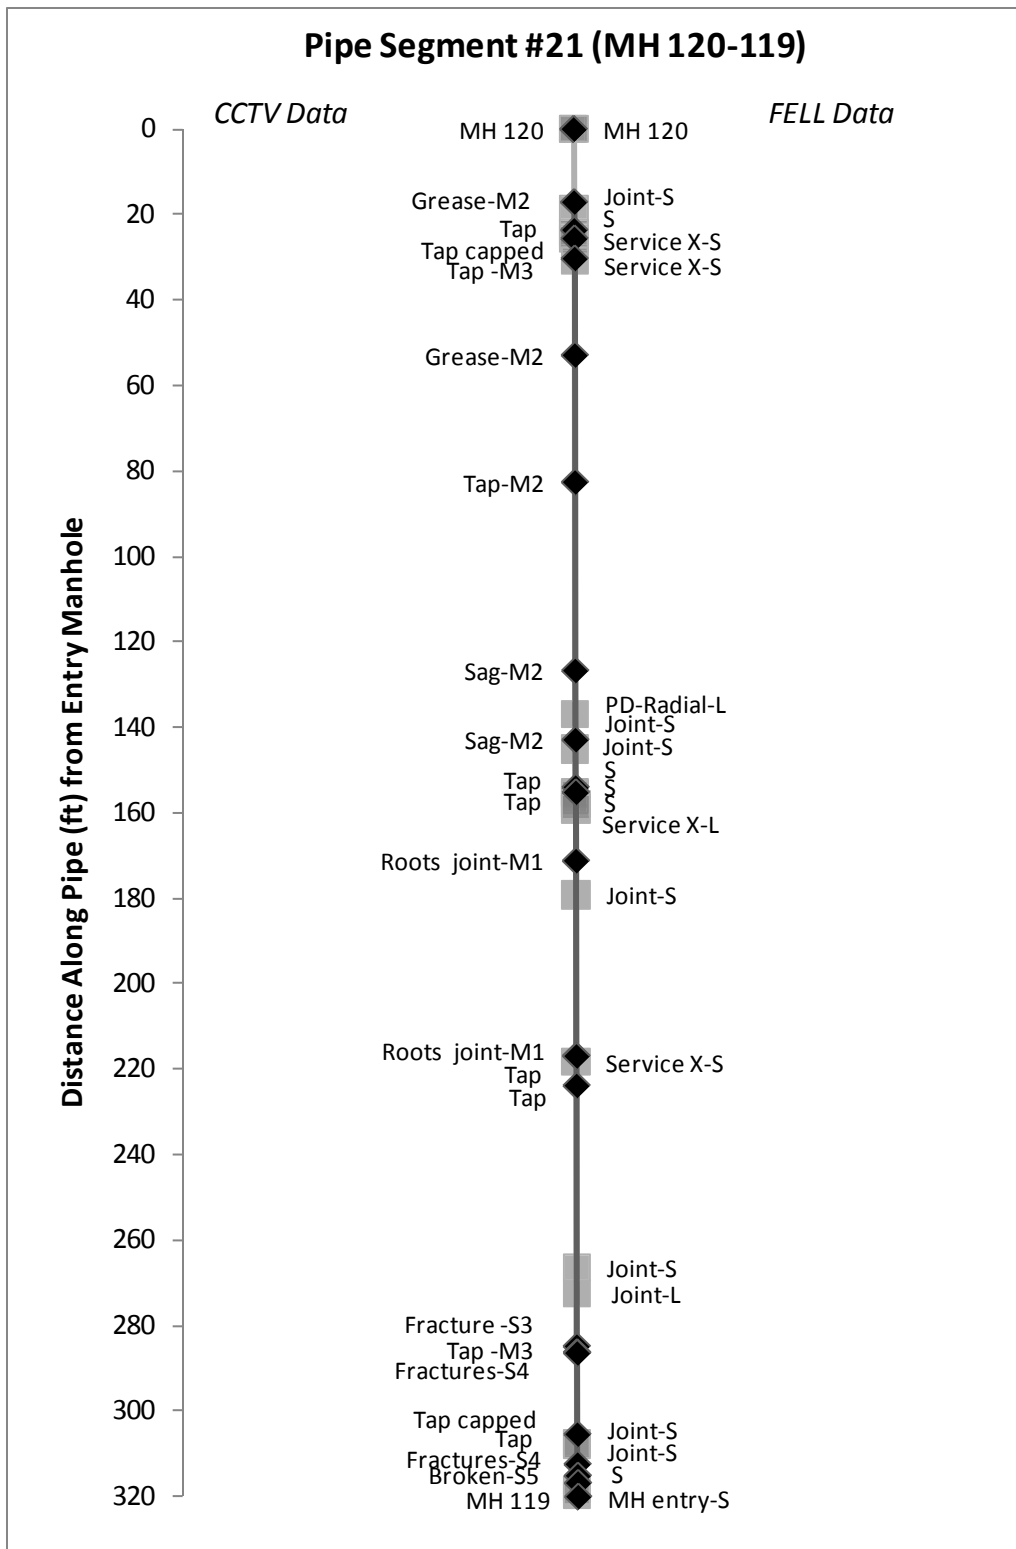
**Figure 6-3. Comparison of Electro-scanning and CCTV for Pipe Segment 120-119.**

A visual review of Figures 6-3 through 6-8 shows that pipe segments with a larger number of CCTV defects, especially defects associated with leakage (e.g., cracks, fractures, defective joints, faulty taps and root intrusion), generally have a larger number of electro-scanning anomalies (e.g., pipe segment #21 in Figure 6-3). Clusters of CCTV defects also often coincide with clusters of electro-scanning anomalies.

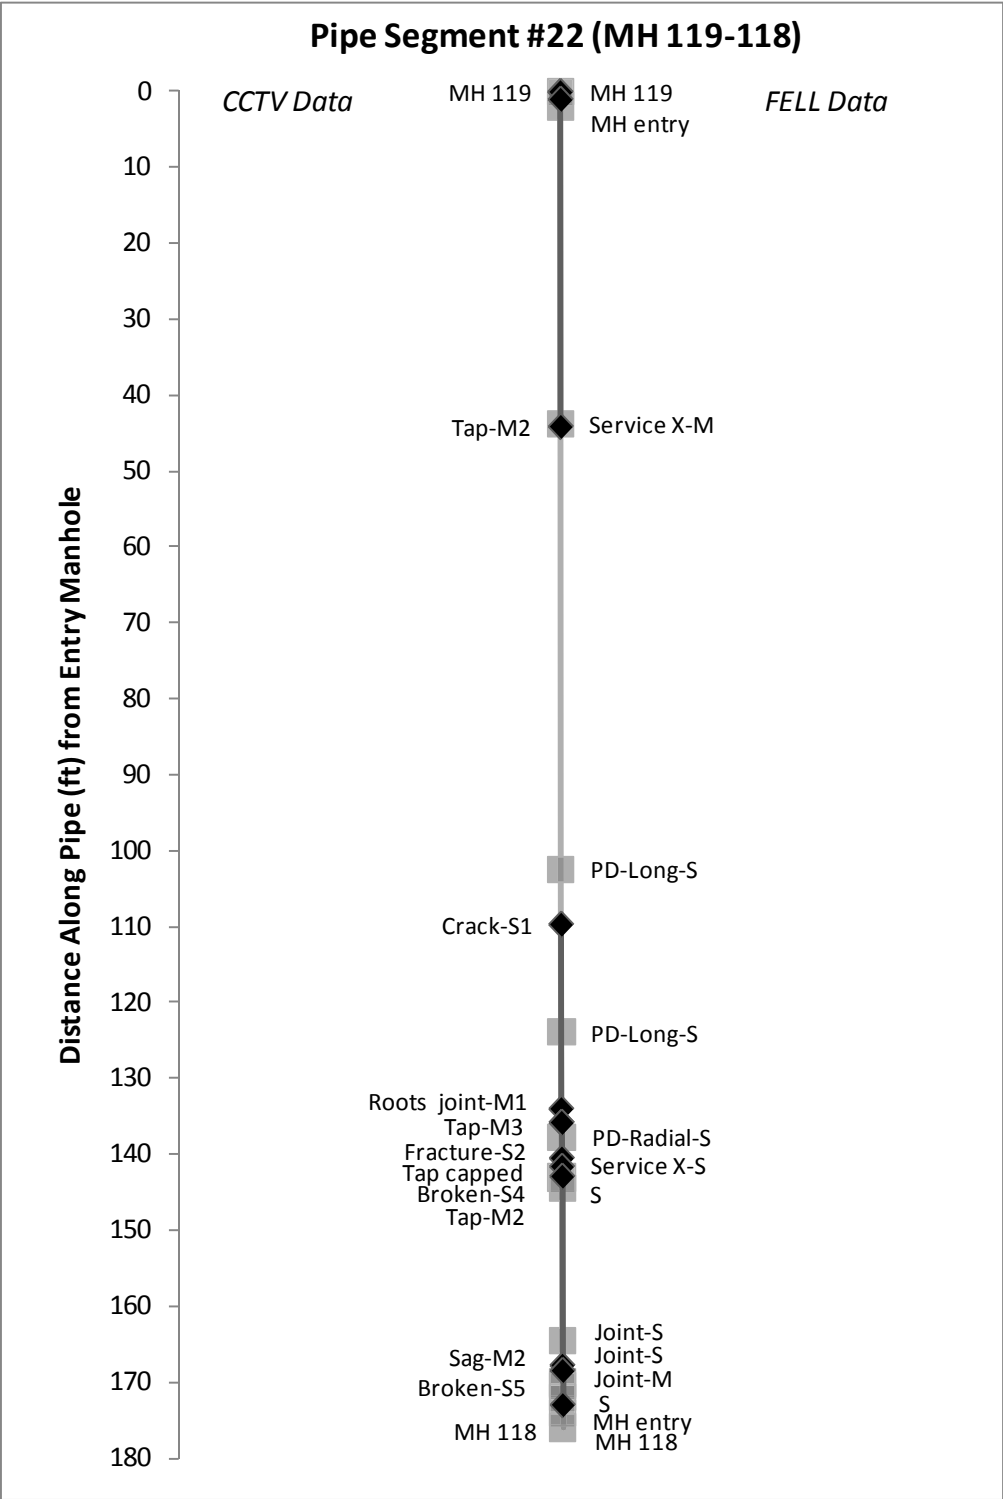
**Figure 6-4. Comparison of Electro-scanning and CCTV for Pipe Segment 119-118.**

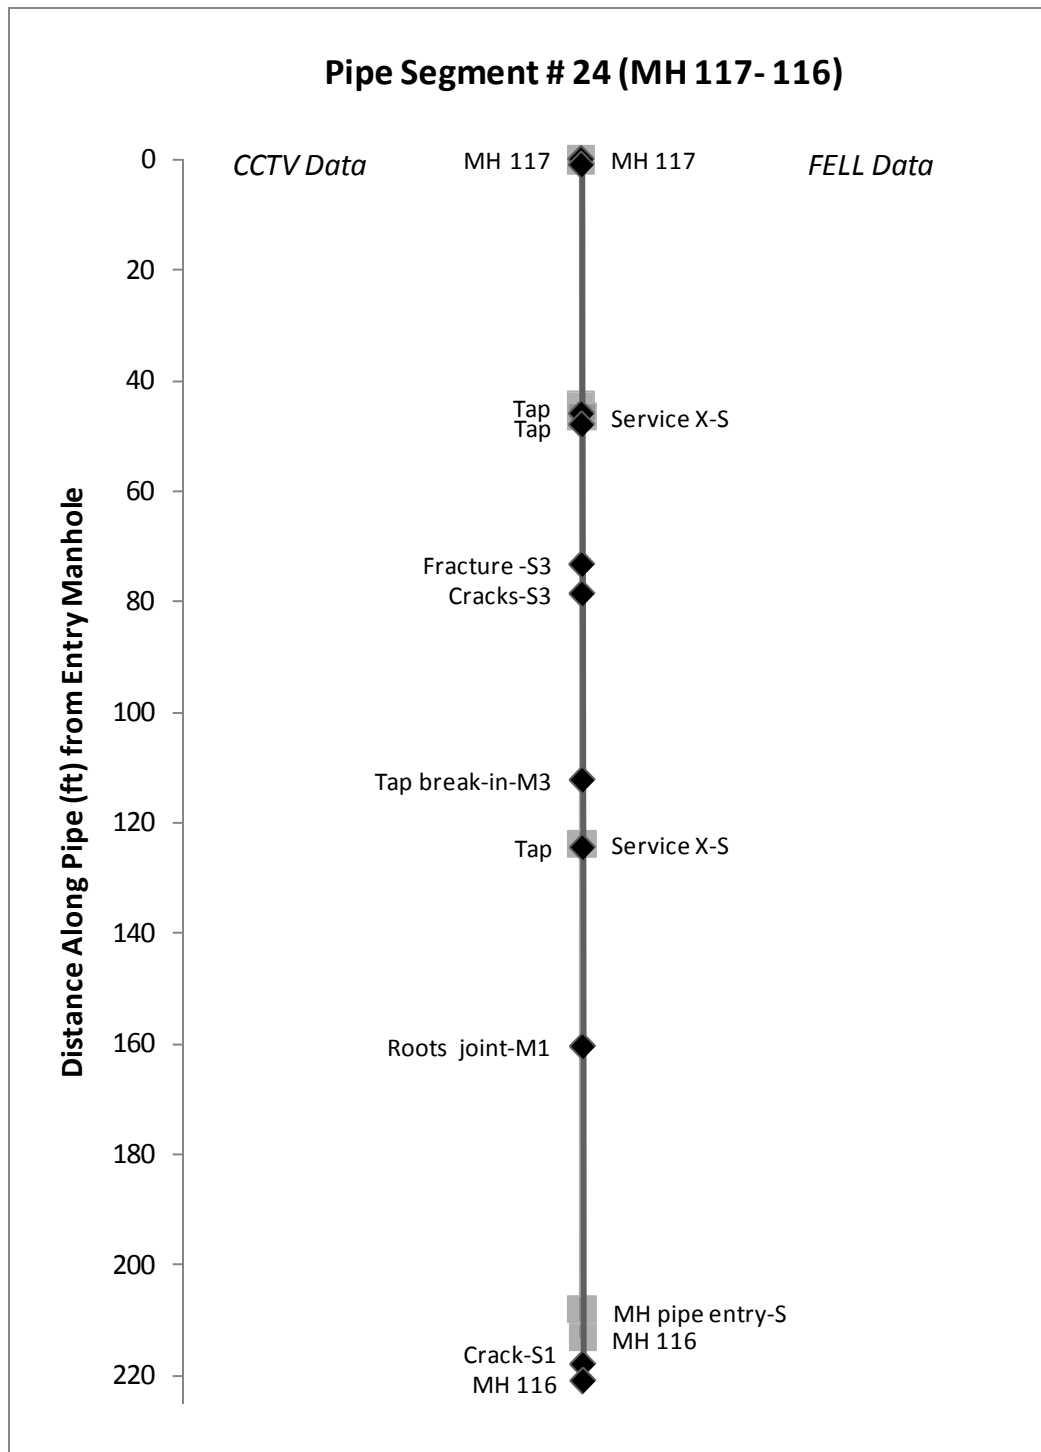
**Figure 6-5. Comparison of Electro-scanning and CCTV for Pipe Segment 117-116.**

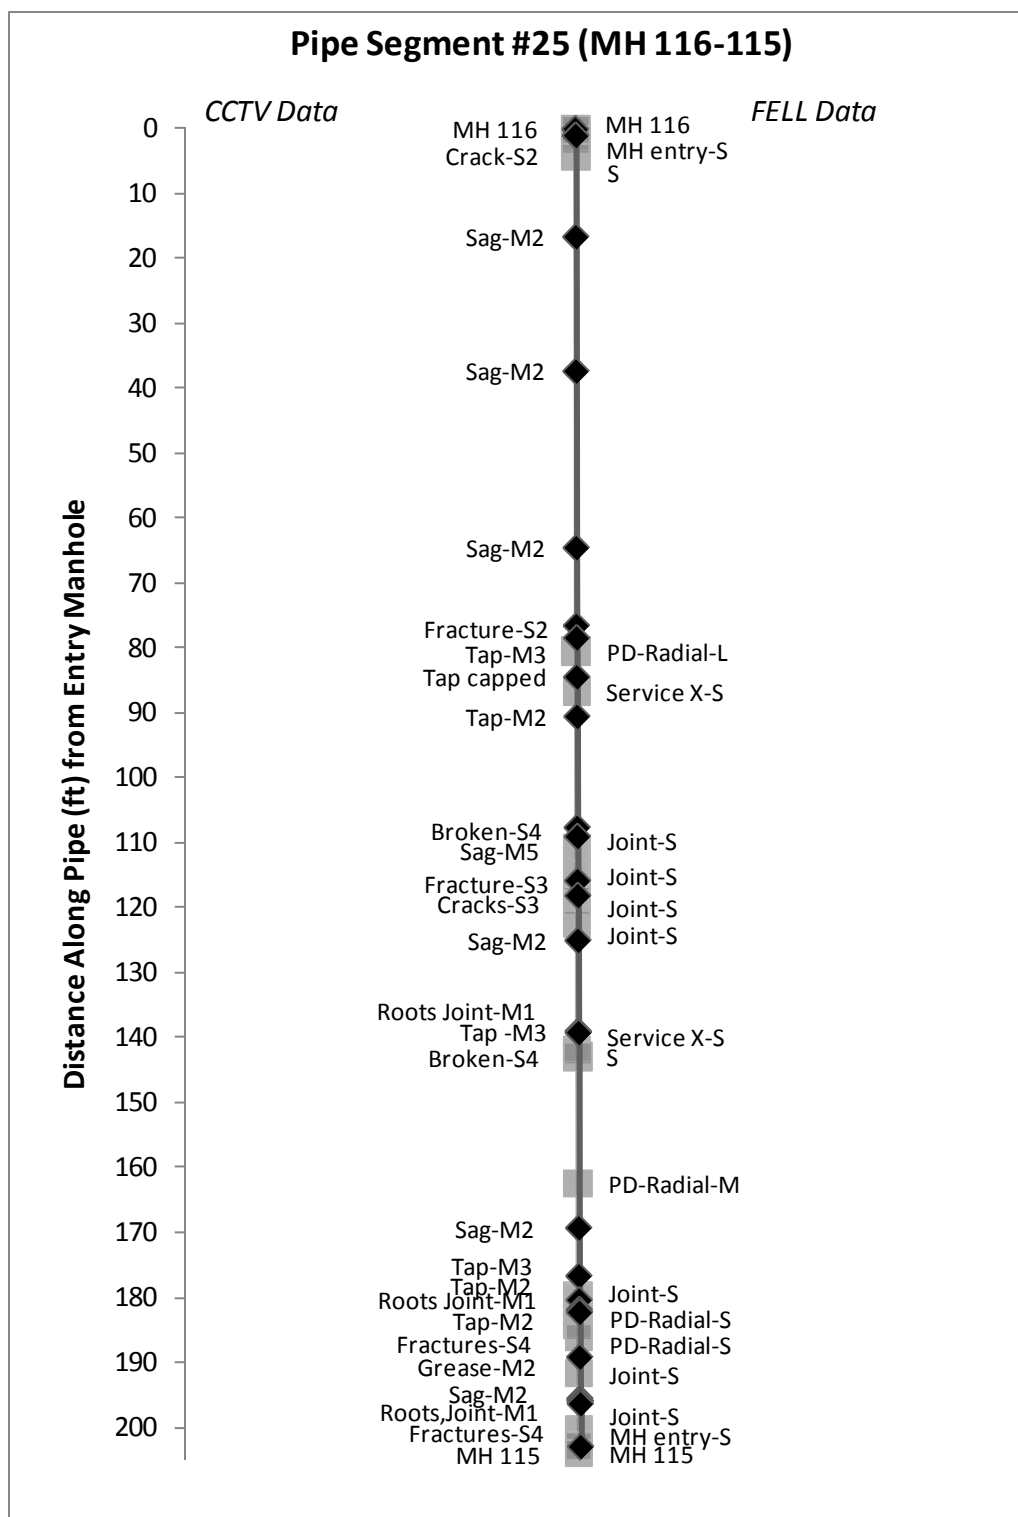
**Figure 6-6. Comparison of Electro-scanning and CCTV for Pipe Segment 116-115.**

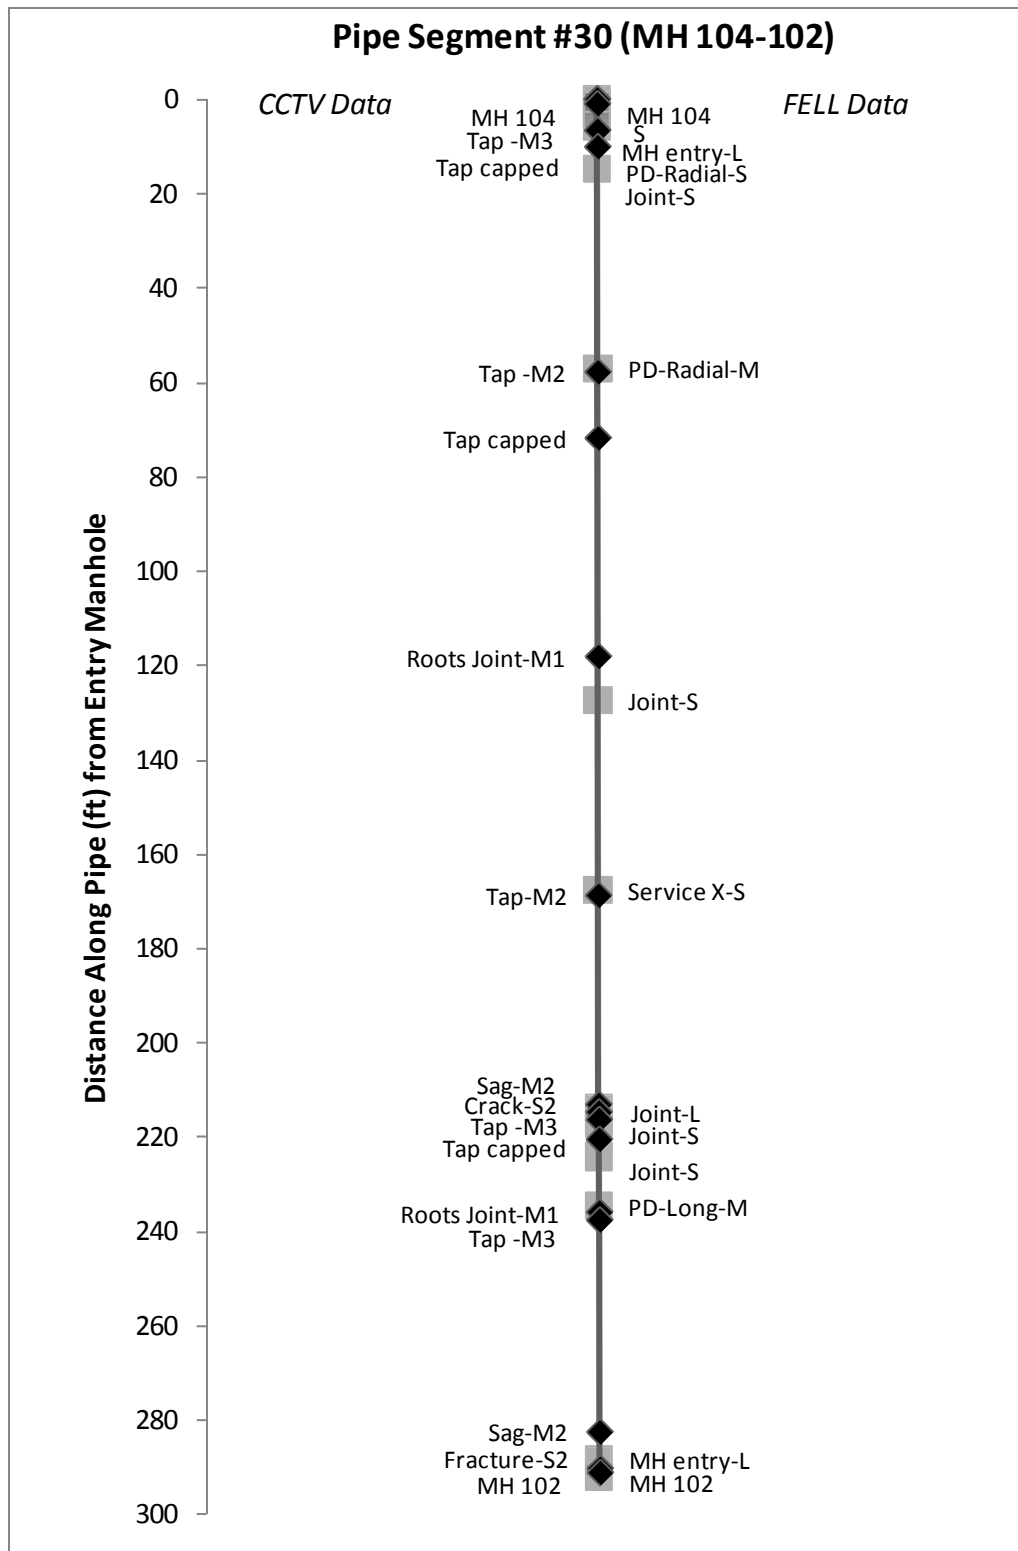
**Figure 6-7. Comparison of Electro-scanning and CCTV for Pipe Segment 104-102.**

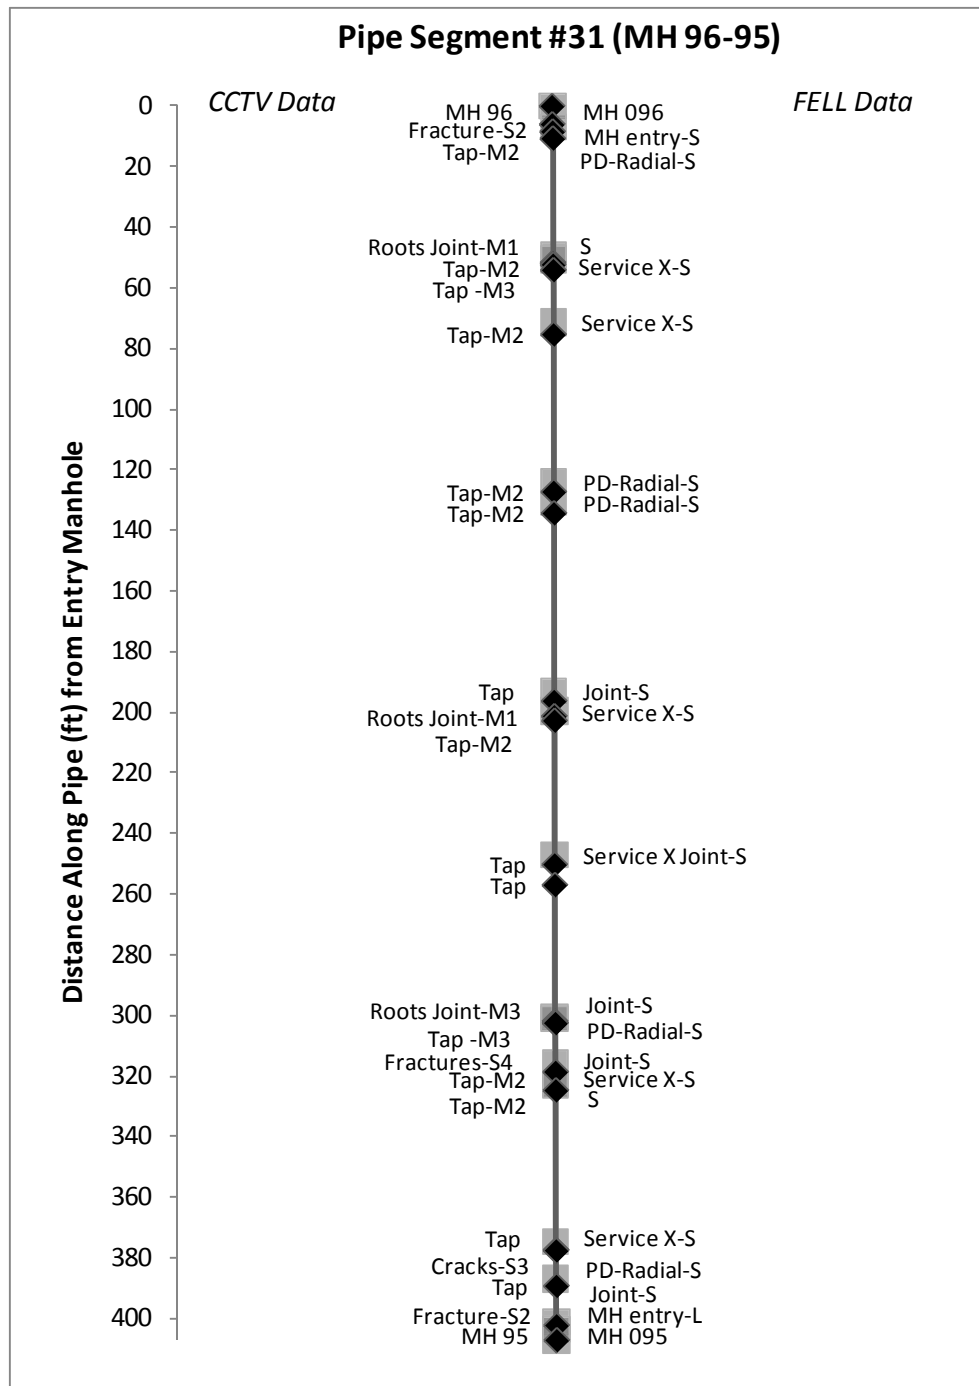
**Figure 6-8. Comparison of Electro-scanning and CCTV for Pipe Segment 96-95.**

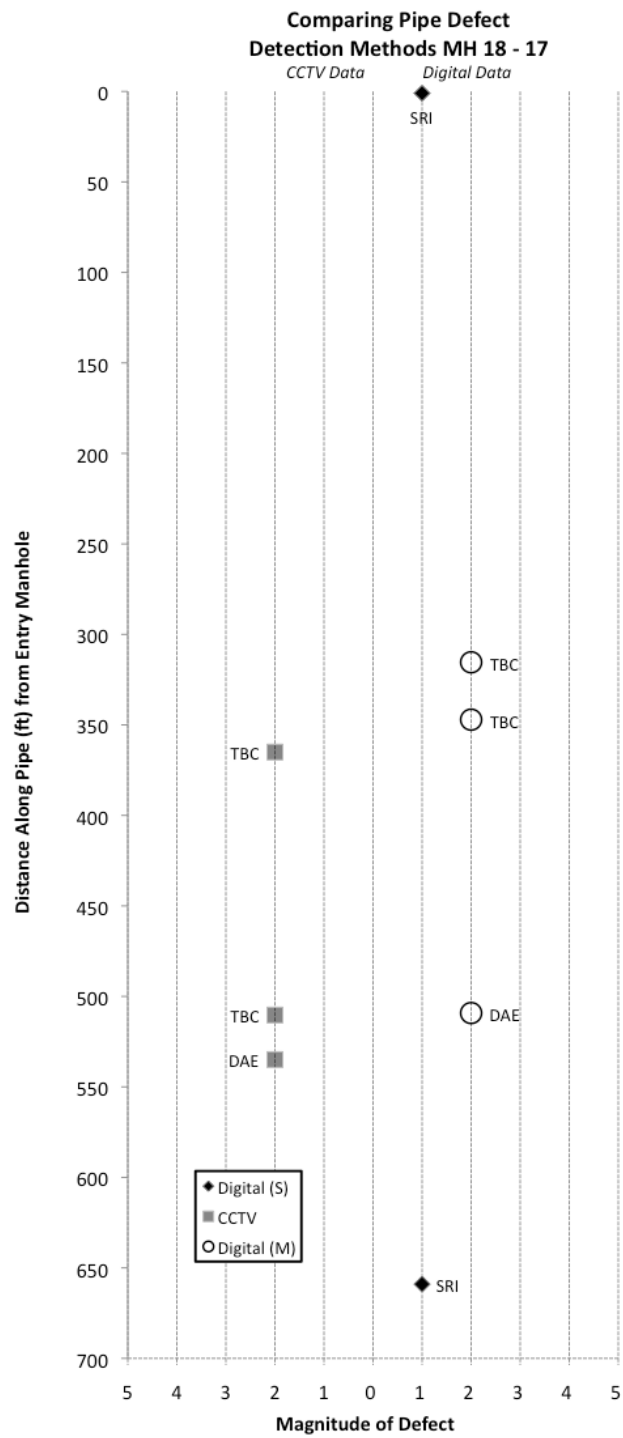
**Figure 6-10. Comparison of Digital and CCTV Defect Observations for Pipe Segment SMH 18-17.**

In contrast, as shown in Figure 6-10 for the sewer between MH 18 and 17, the encrustation deposits (coded as DAE) and the capped sewer connection defects (coded as TBC) of the same grade were located in similar locations. For example, a single encrustation deposit was noted in the CCTV data at 535-ft and the deposit noted in the digital scan was located at 509-ft. In addition, a capped sewer connection defect was identified by the CCTV at 365 ft while the digital scan noted capped sewer connection defects at 315-ft and 347-ft.

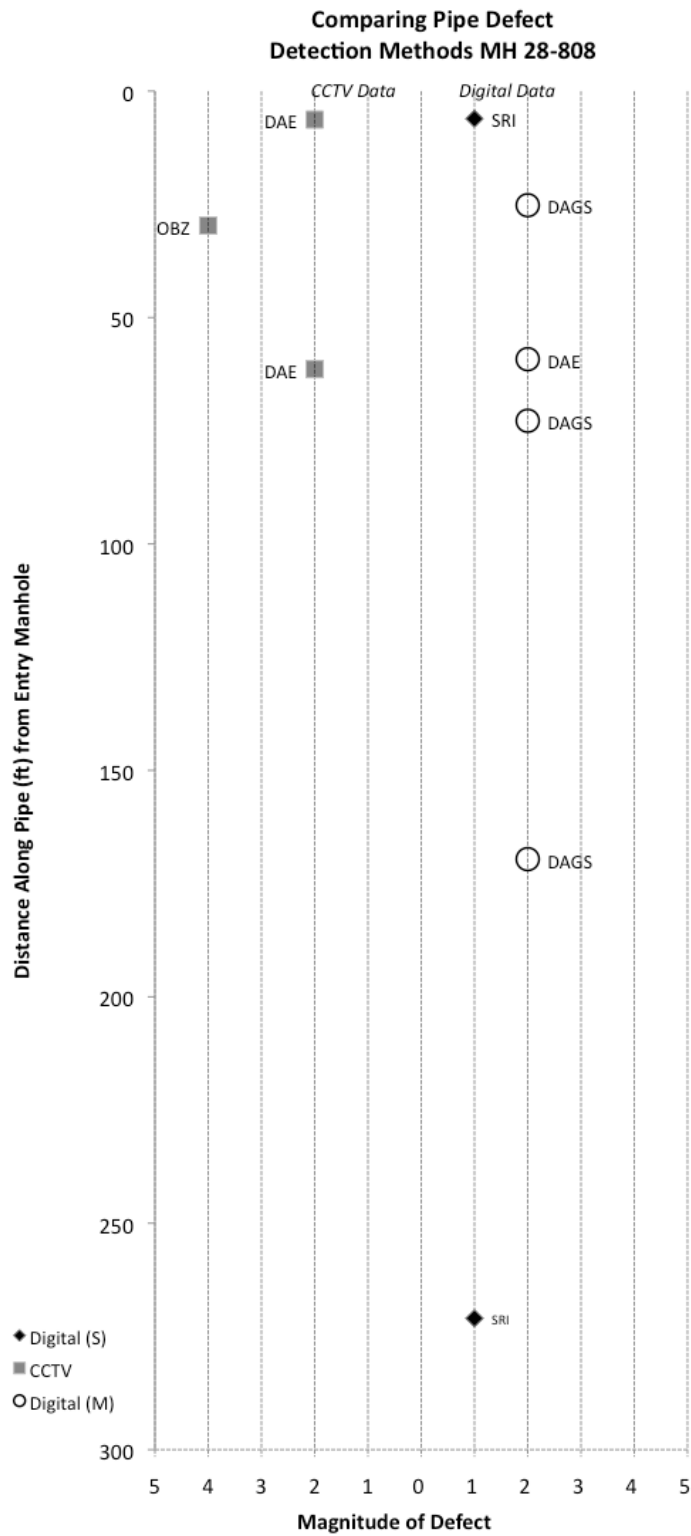
**Figure 6-11. Comparison of Digital and CCTV Defect Observations for Pipe Segment SMH 28-808.**

As shown in Figure 6-11, the operational defects identified by CCTV and the digital scan were similar in location and grade in the first 100-ft of the sewer between MH 28 and 808. For example, the location of the obstacle identified in the CCTV inspection, coded as OBZ, appeared to coincide with the grease deposit, coded as DAGS, noted in the digital scan. Similarly, the encrustation deposit, coded as DAE, noted during the CCTV inspection at 61-ft appeared to coincide with the encrustation deposit, coded as DAE, identified by the digital scan at 59-ft. However, deposits were identified in the CCTV inspection that were not noted in the digital scan (e.g., DAE at 5-ft) and deposits noted in the digital scan that were not identified in the CCTV inspection (e.g., DAGS at 75-ft and at 175-ft).

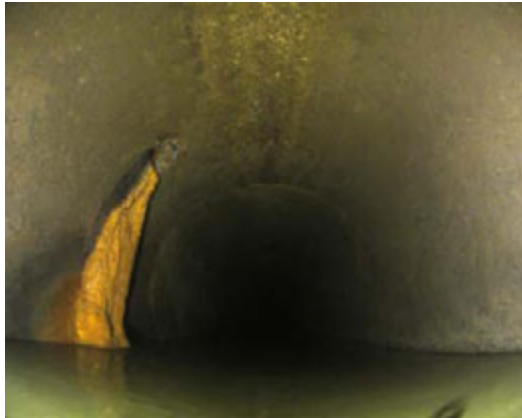
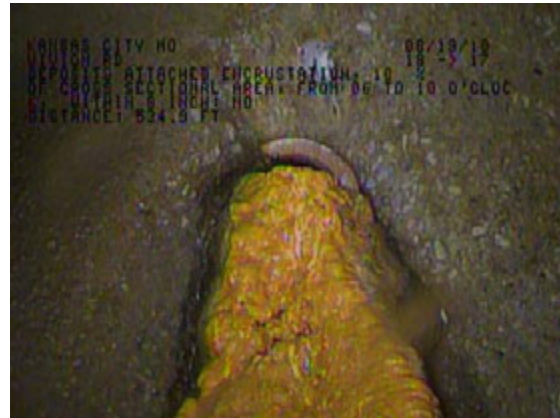
**Figure 6-12. Encrustation Deposit Between SMH 18 and 17  
Digital Scan (Multi-sensor) (left), CCTV(right).**

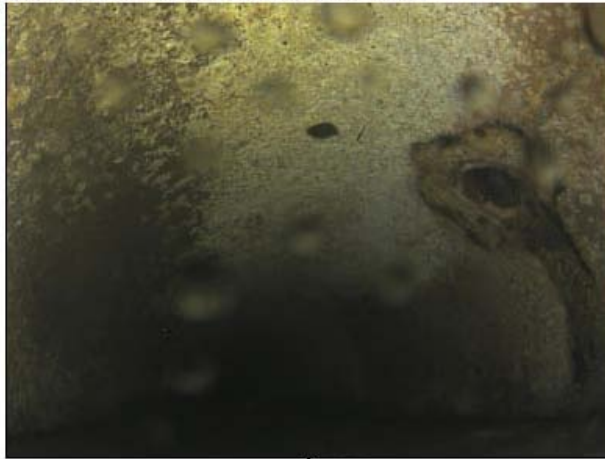
532ft Point of Interest - Lateral connection

Photo: 19, Tape/Media No.: 081810DJ, 00:12:24  
534.3FT, Tap Break-In Capped, at 02 o'clock, 8", within 8 inch:  
NO

**Figure 6-13. MH 1-18, Multi-sensor Data (left) and CCTV Data (right) of Capped Lateral.**
